Re: Electrical Assessment

Inspection Report
214 - 216 E. 2nd Street
Hastings, MN 55033

09/24/19

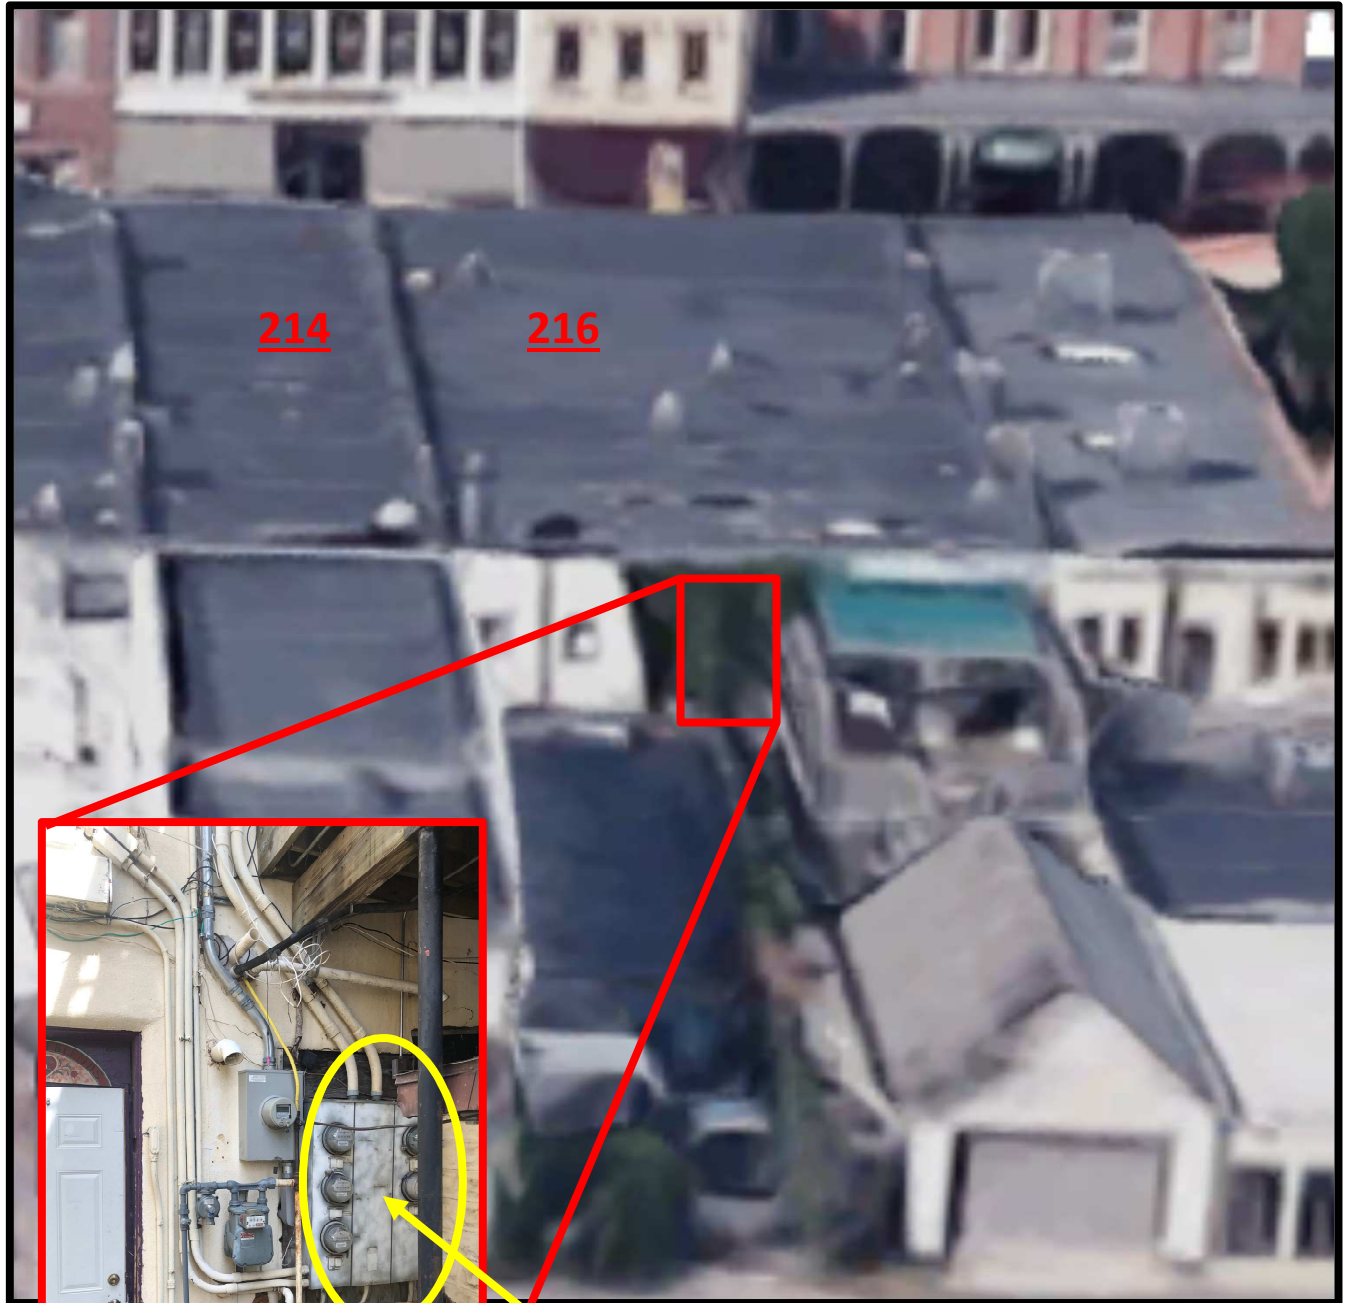
Although the main electrical service is on the south side of building 216, it also feeds building 214. Code requires each structure (PID number) to have its own electrical service.

2 of the existing meters feed building 214 and 3 of the existing meters feed building 216.

1. Replace the existing damaged main service with (2) new services (1 of each structure).
2. Update the main service grounding as needed to meet current code requirements.
3. Replace (5) existing FPE panels with new GE panels and AFCI circuit breakers as required by code.

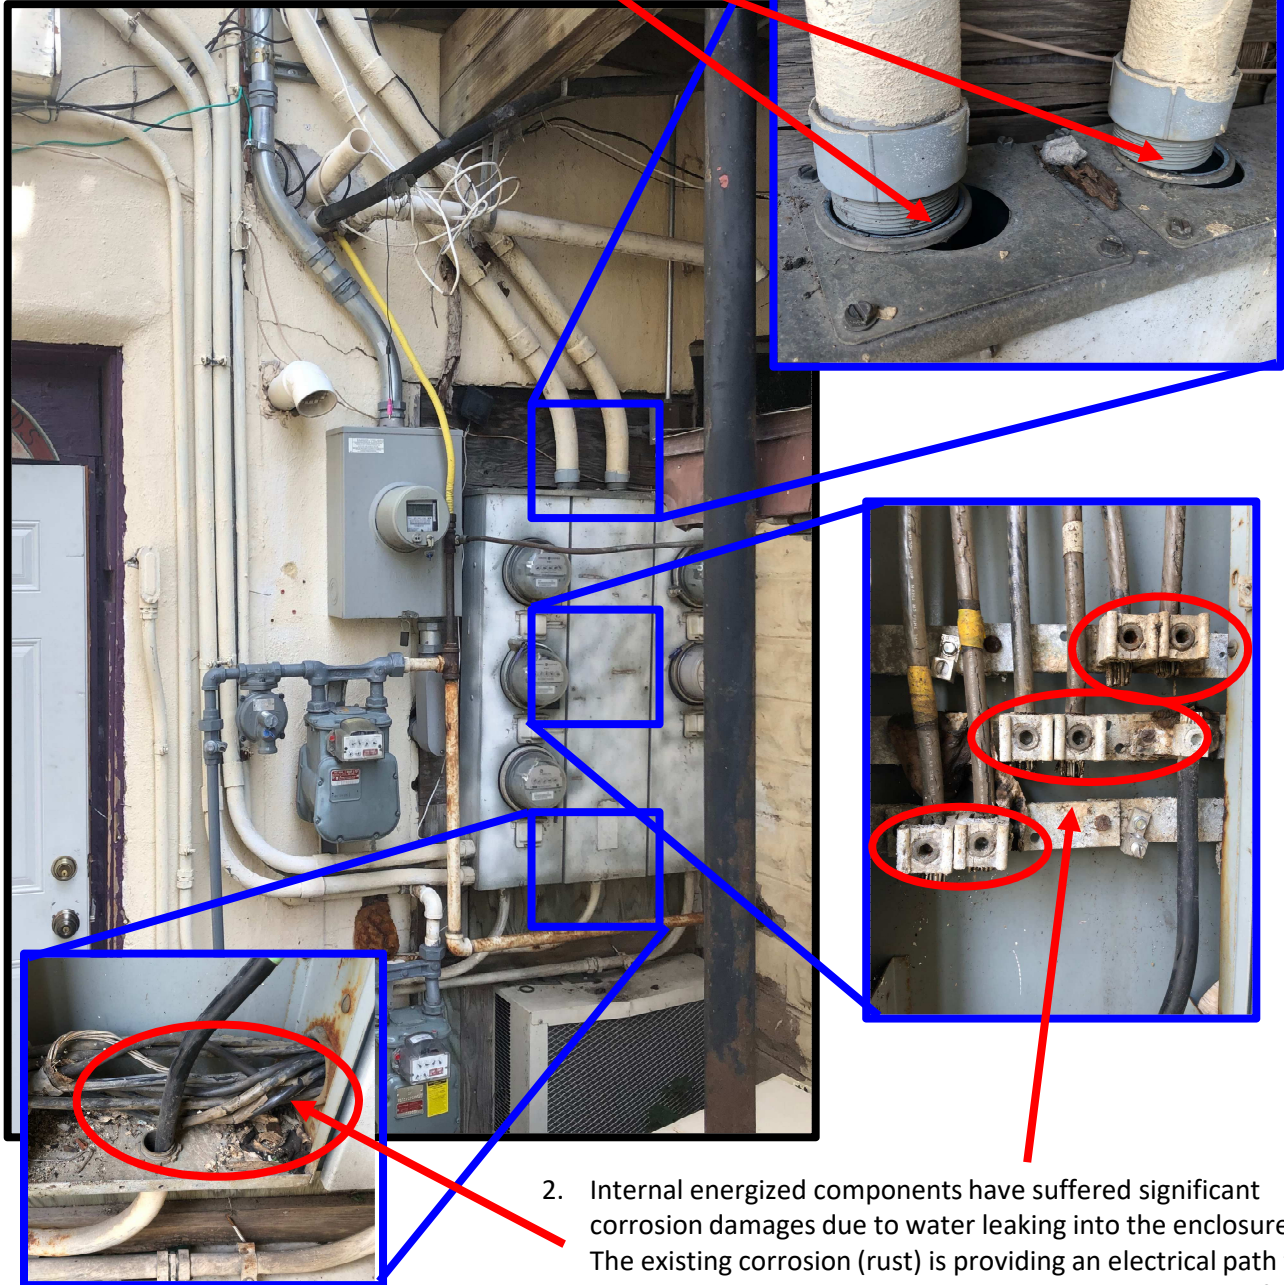
1. Damaged fittings on top of the meter socket is allowing water to enter the enclosure causing significant corrosion to the electrical components.

2. Internal energized components have suffered significant corrosion damages due to water leaking into the enclosure. The existing corrosion (rust) is providing an electrical path to ground and will most likely cause a serious short-circuit fault resulting an electrical fire.

WARNING – Existing conditions present a serious risk of electrical fire and/or electrical shock. Do not use until repaired and inspected.

1. Replace main electrical service (meter sockets and main breakers) and update grounding to meet current code requirements.
2. Replace (5) existing circuit breaker panels and install new AFCI circuit breakers where required by code.

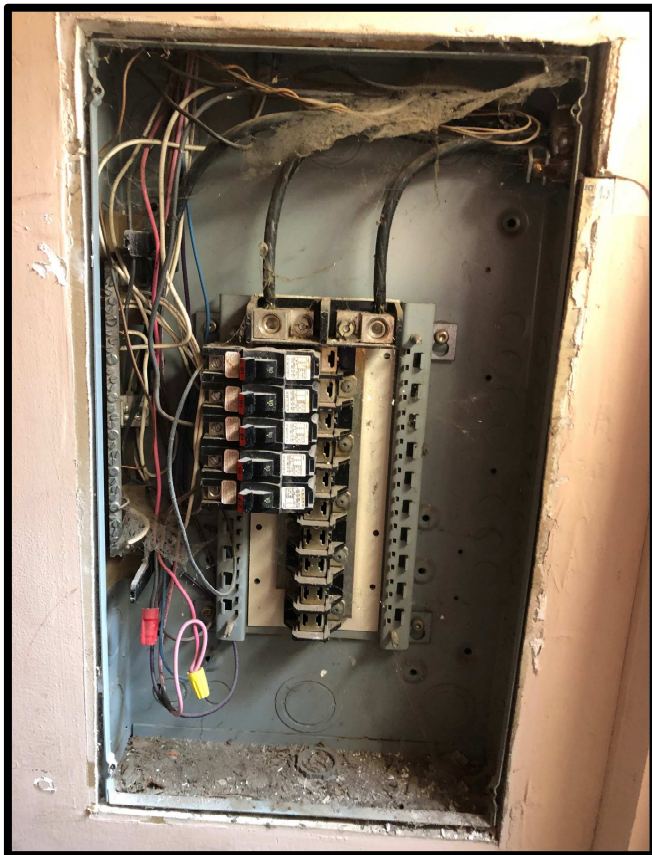
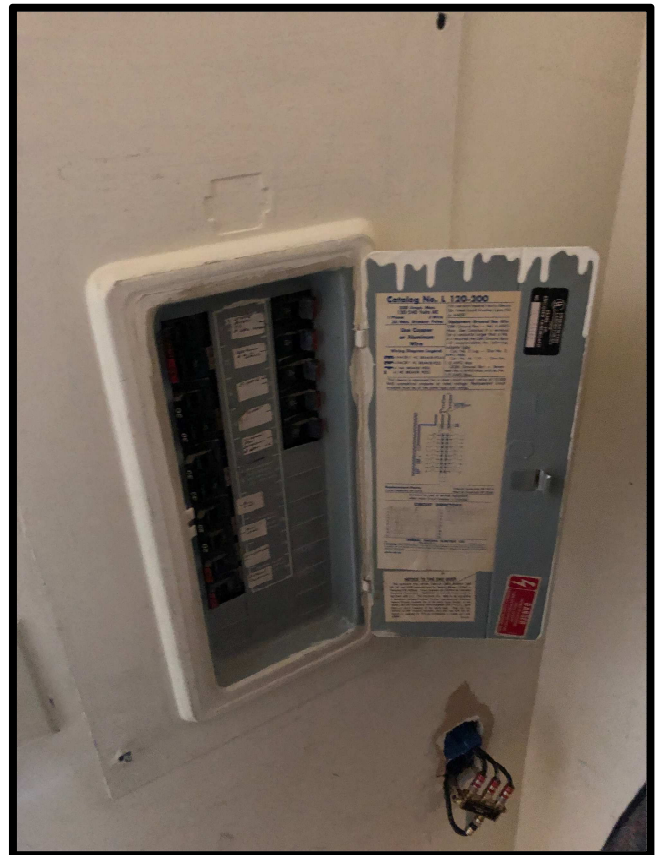
3. The (5) existing electrical panels were manufactured by Federal Pacific (FPE). FPE equipment is known to have caused many electrical fires and was taken off the market in the early 1970's.
4. The existing (5) panels are in very poor condition and are not compatible with AFCI circuit breakers as required by code. These panels should be replaced as soon as possible.
